Sabine National Wildlife Refuge Erosion Protection (CS-18)

Project Status

Approved Date: 1991 **Cost:** \$1.59 million
Project Area: 13,000 acres **Status:** Completed
Net Benefit After 20 Years: 5,542 acres March 1995
Project Type: Shoreline Protection

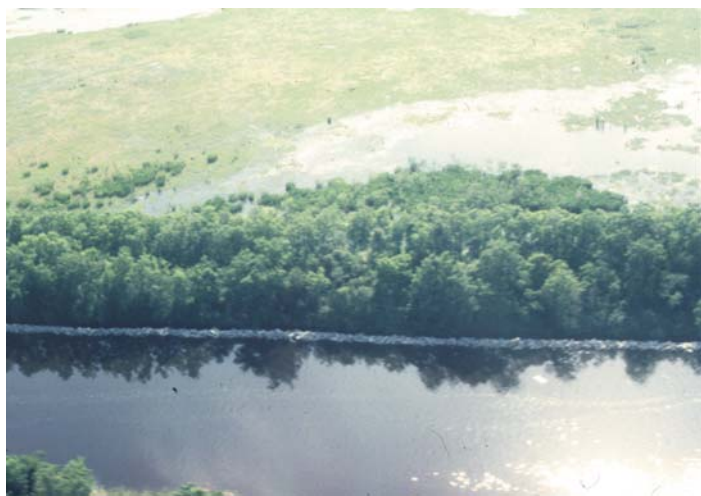
Sabine National Wildlife Refuge Erosion Protection looking eastward across the Burton-Sutton Canal into Pool 3. The continuous rock breakwater is seen along the shoreline in the lower third of the photo.

A 5.5 mile-long, continuous, free-standing rock dike was built along the east bank of the Burton-Sutton Canal and forms the western boundary of Pool 3.

The levee appears to be stable, and the rock dike seems to be in good condition at this time. Future inspections of the project area will be conducted at regular intervals to document the condition of the rock breakwater and any required maintenance. This project is on Priority Project List 1.
